**313 PORTRUSH RD
NORWOOD SA 5067**

CERTIFICATE OF INSPECTION

(ASBESTOS RELATED ONLY)

C19-5521

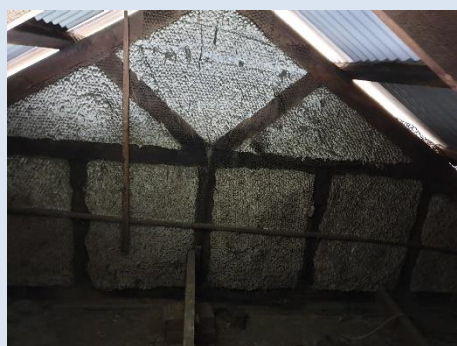
LOCATION AND FEATURE	SAMPLE NO.	ANALYSIS RESULTS	PHOTO
Internal Ceiling Cavity: Gable end plaster and wire mesh to the front of the property.	1	No Asbestos Detected
