DUE DILIGENCE ENVIRONMENTAL REPORT

10 STACK STREET FREMANTLE, WA

JOB NO: 08.054

REPORT NO: RP001

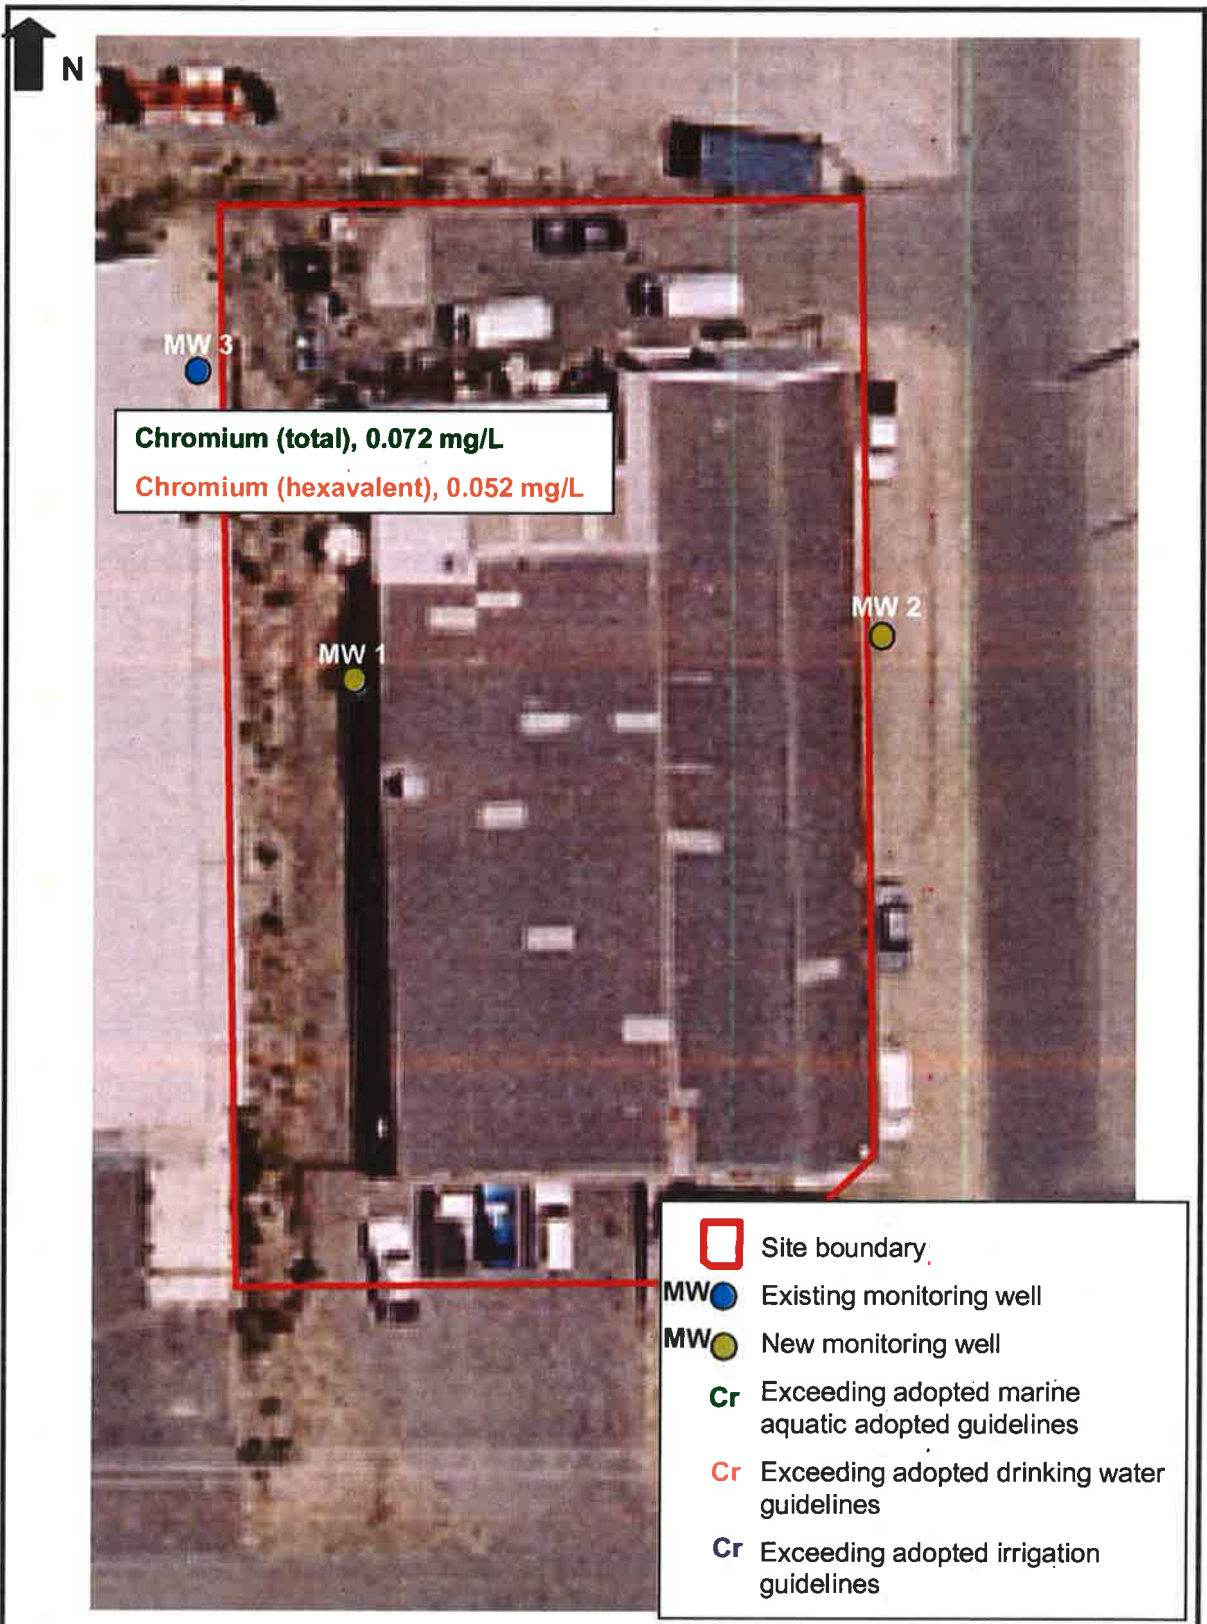
FIGURE 6 : MONITORING WELL LOCATIONS AND EXCEEDENCES

Groundwater contamination exceeding investigation levels was only identified down gradient of the north west corner of the site. No contamination was identified in the monitoring wells in the middle of the western and eastern boundaries of the property. It is likely that groundwater contamination, if present onsite is restricted to the northern end of the property.

It is not certain as to whether contamination identified in groundwater collected from MW3 originated from the sump (east) or from the property (Lots 1211 and 1218 Wood Street) adjacent to the north.

Further groundwater investigations are recommended to determine whether the contamination identified is from an onsite or an offsite source. This would involve installation of additional monitoring wells to delineate the area of groundwater contamination.

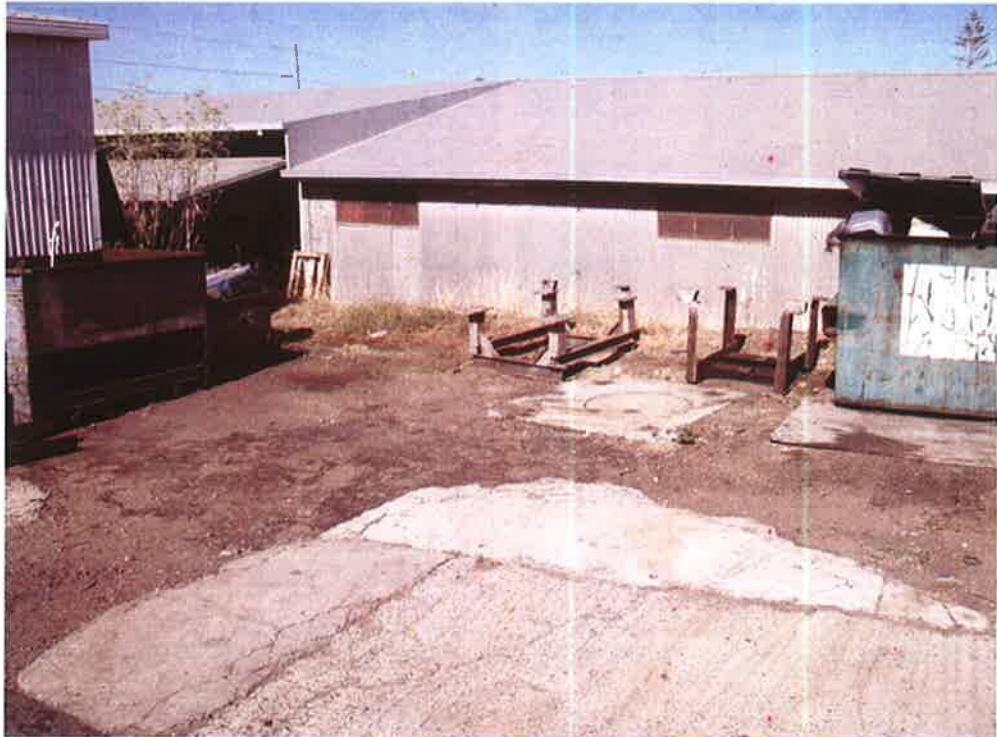
The sump located in the north-west corner of the site is a possible groundwater contamination source.

PLATE 1: Bitumen driveway at rear of property and drainage sump, visible in middle ground.

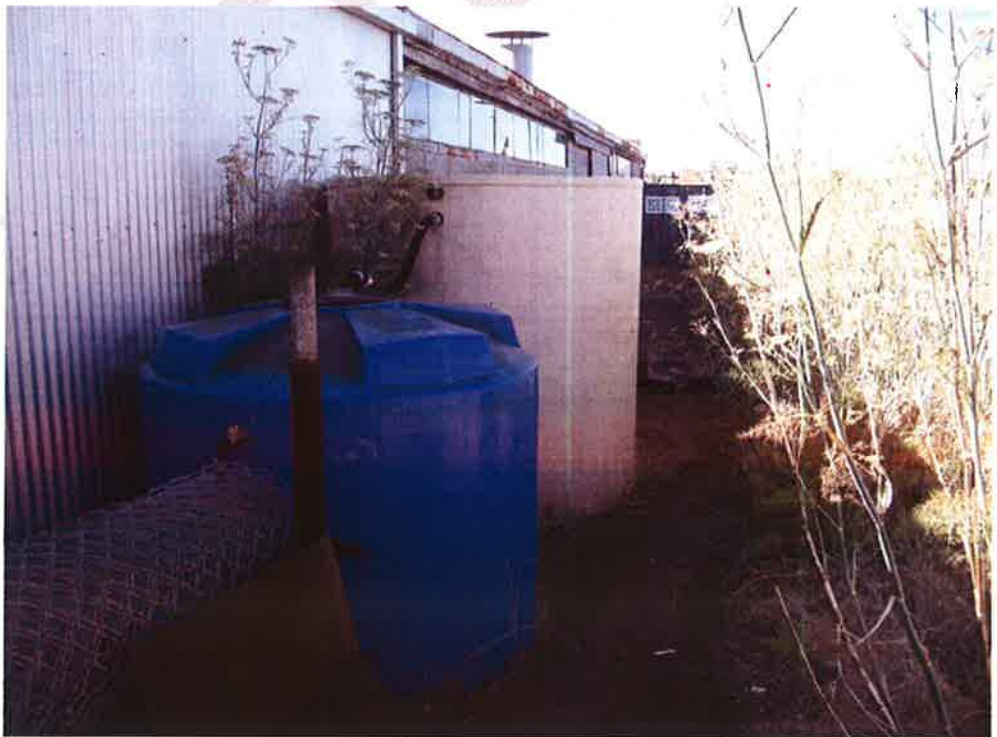
PLATE 2: Two separator tanks on the western side of the building.

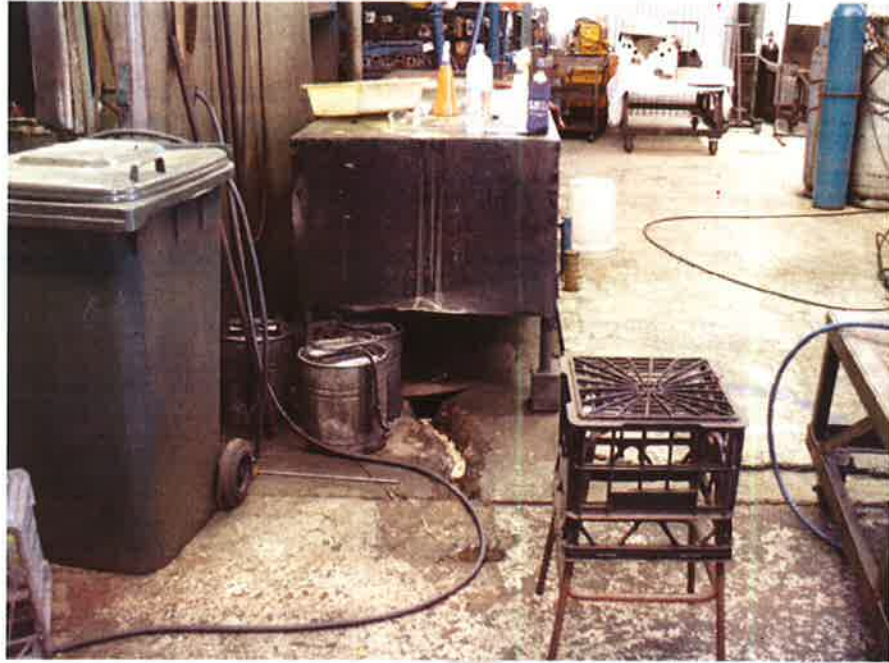
PLATE 3: The location of the settling tanks within the workshop

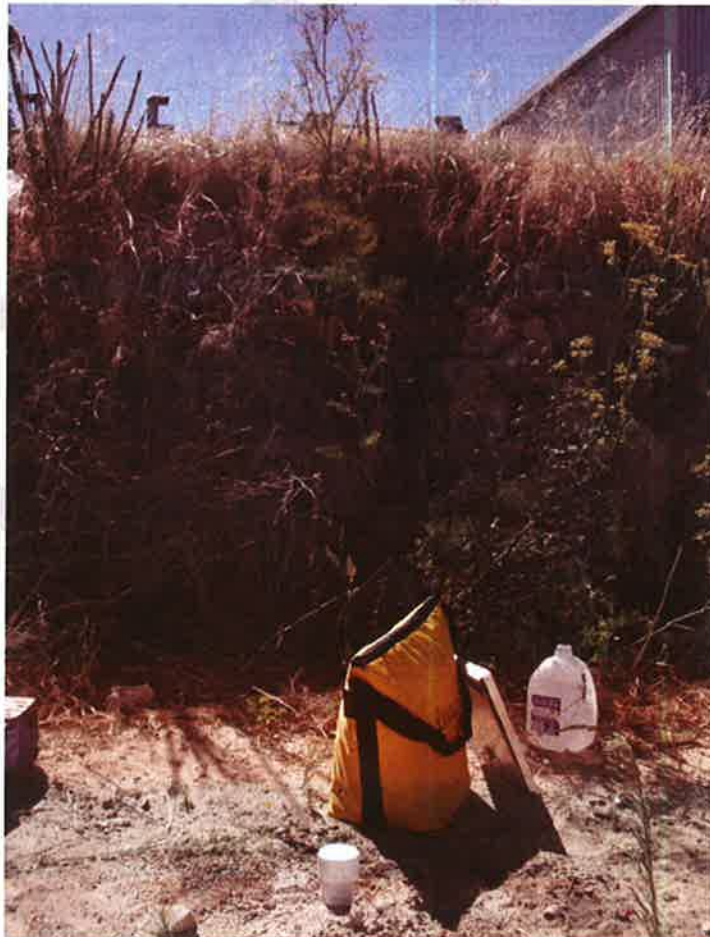
PLATE 4: Existing monitoring well MW3 in foreground and the exposed limestone wall on the western site of site.

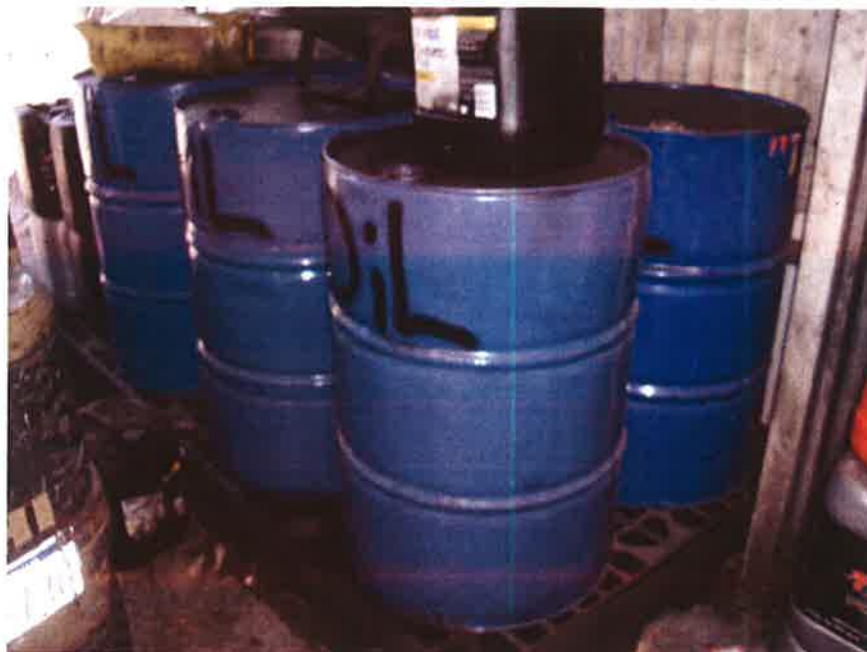
Chemicals are stored in an unbunded area in the more recent extension area. Some evidence of staining was present.

PLATE 5: Chemical storage in unbunded area within workshop

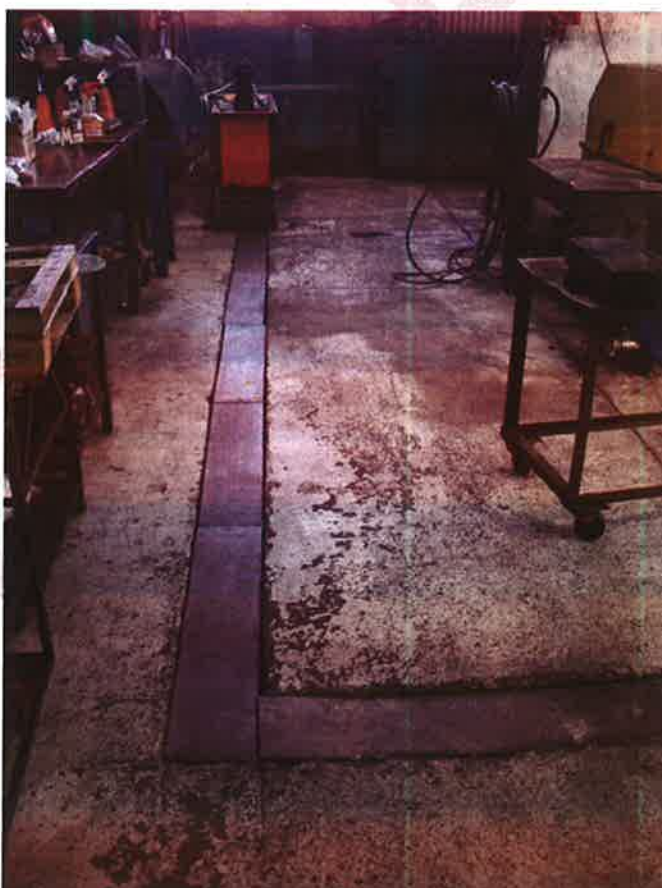
PLATE 6: Drains (leading to settling tanks) surrounding the wash down area within the workshop.

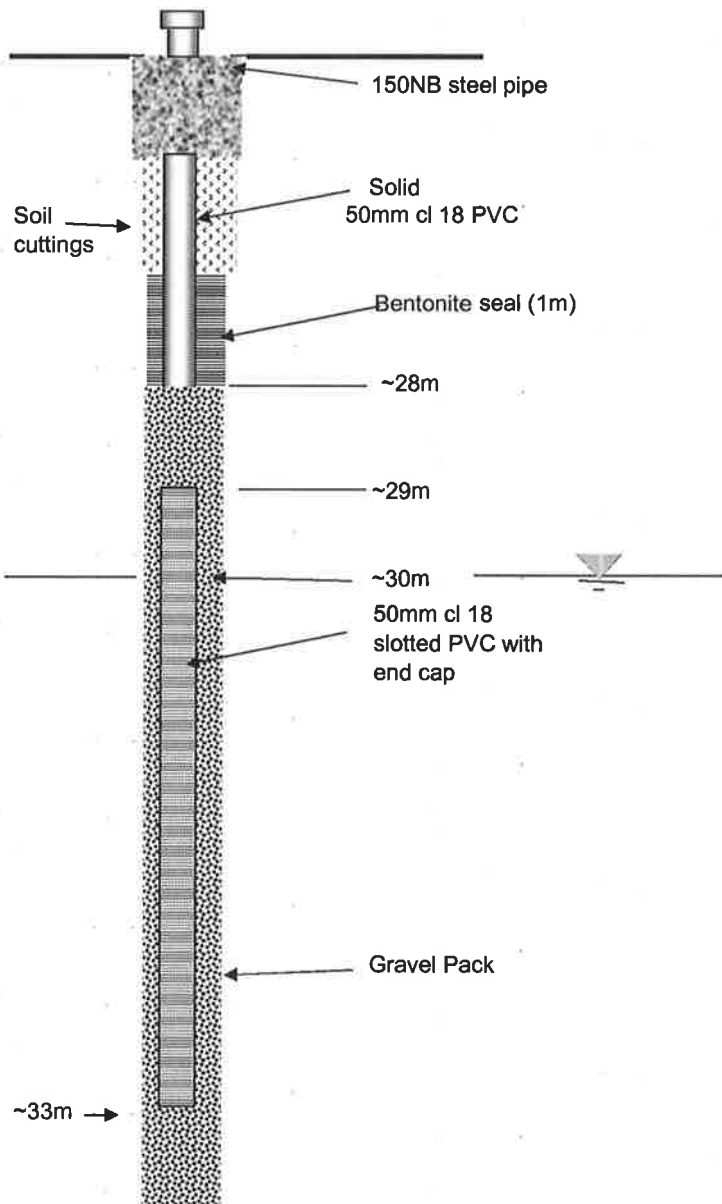
Figure E1 - Well Construction Diagram

- Use of washed 50mm Class 18 PVC with 0.5mm machine slots over the bottom 3m of the bore casing. Slotting will extend at least 1m above the observed groundwater level to intercept any separate-phase hydrocarbons (SPH) and to accommodate fluctuations in the groundwater level. No glues or solvents will be used in the groundwater monitoring well construction;
- Filling of annulus between the casing and the borehole wall with a graded and washed coarse silica sand pack;
- Sealing of annulus with at least 0.5m of bentonite slurry with a concrete collar at the ground surface;
- Development of the monitoring bores to remove fines; and
- Surveying of the top of PVC casing to enable determination of groundwater elevation contours.
